# Shawnee Mission Post Office, Mission, KS: Delivery Operations

## AUDIT REPORT

Report Number 24-107-3-R24 | July 15, 2024

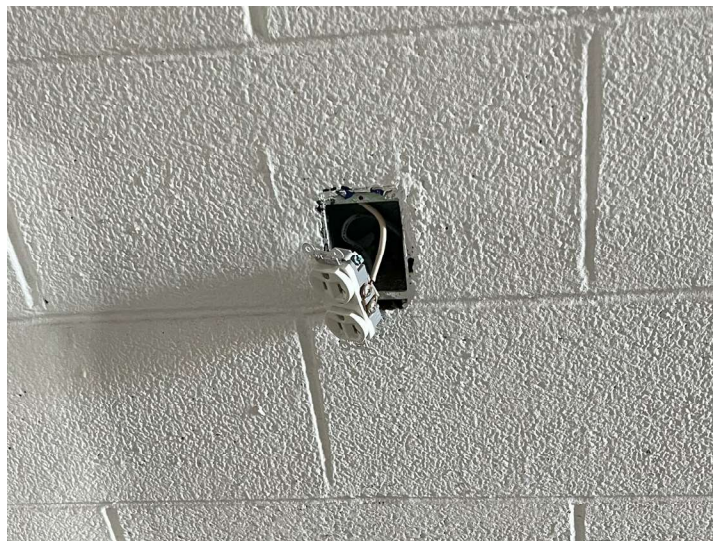
**Figure 5. Broken Electrical Outlet**

- Twenty fire extinguishers were missing annual inspections and two were missing monthly inspections.<sup>32</sup>
- One fire extinguisher was not mounted on the wall.
- There was an electrical outlet hanging from the wall in the basement area (see Figure 5).

Management did not provide sufficient oversight and take the necessary actions to verify that property condition issues were corrected. Management was aware of the missing and stained ceiling tiles. Maintenance personnel had tried to complete the annual fire extinguisher inspections but later learned that they needed to be completed by an outside contractor. Management was not aware that two of the extinguishers were missing a monthly inspection. Further, they did not identify and address other issues, such as the broken outlet and unmounted extinguisher, as they were located near a construction area related to the S&DC conversion

*Property Conditions:* Management has abated one of the six property conditions related to safety, security, and maintenance and working to either fix or complete work orders for the remaining items.

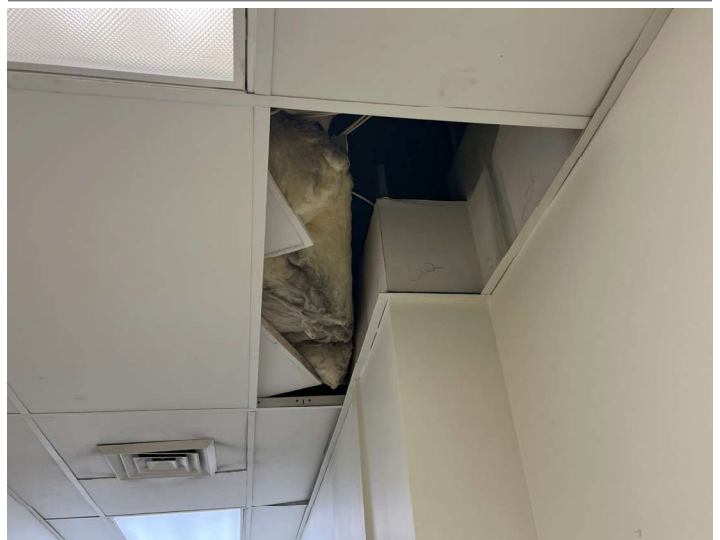
**Figure 6. Missing Ceiling Tile**

- There was a corroded pipe in the women's restroom.
- There were missing ceiling tiles in the office passageway (see Figure 6).
